# Manhole Inspection Summary

Manhole # S29II2006MH

Insp Date: **1/9/07 1:22 PM**

**Location** Address: **6001 CHARLES ST**

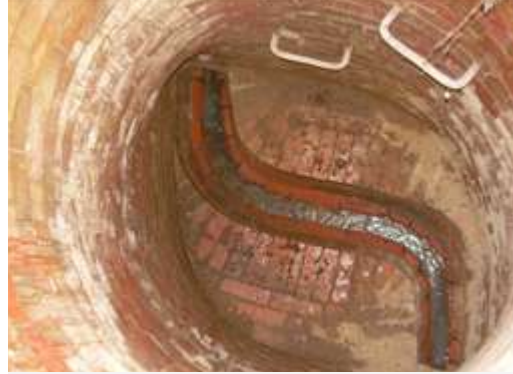
Top View

Bench debris.

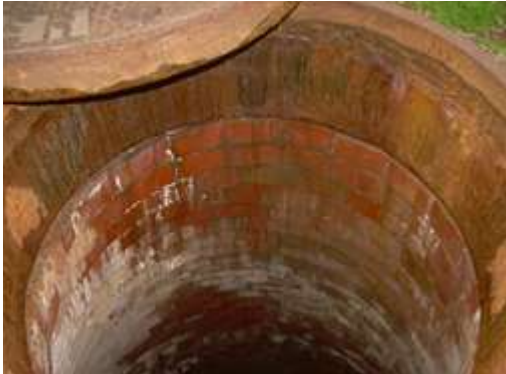
Defect

Frame leaks. Adjustment deterioration and infiltration. Corbel and Barrel infiltration.

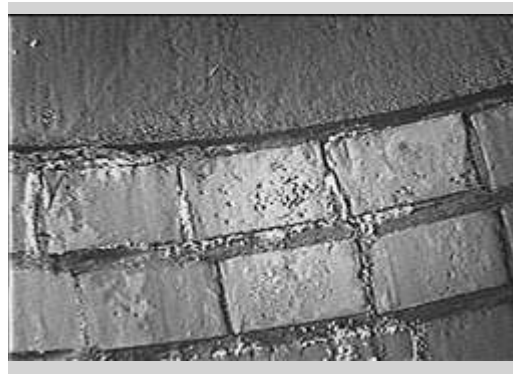
Defect

Frame leaks. Adjustment deterioration and infiltration.

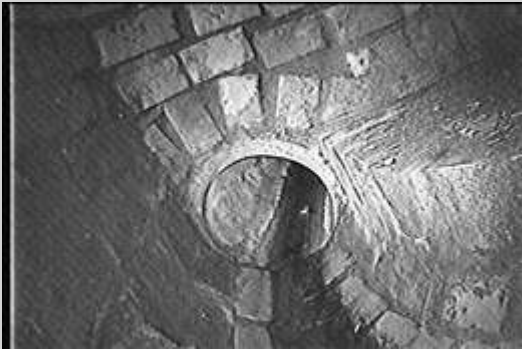
### 8 in. Circular Gravity Sewer Pipe Out @ 12 O'Clock

Deposits: ☐ None ☐ Mud ☐ Sludge ☐ Debris ☒ Grease

Silt Depth: **0** (in.) Deposits Extent: **Light**

Infiltration: **None** Pipe Seal Cond: **Unknown**

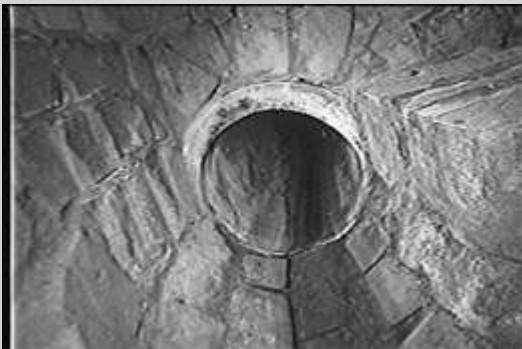
### 8 in. Circular Gravity Sewer Pipe In @ 6 O'Clock

Infiltration: **Evidence** Pipe Seal Cond: **Unknown**
